HARRY J. ENNS WETLAND DISCOVERY

DRAWING OVERVIEW

**BASED ON: EXHIBIT DESIGN
PACKAGE of March 10, 2023**

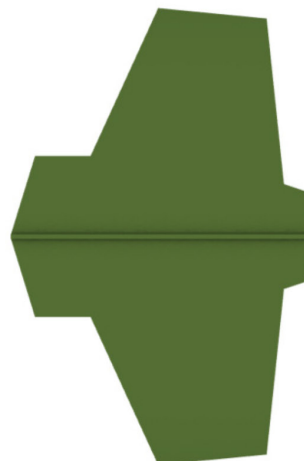
Type 3 Hush Acoustics Panel Abstract
Not to scale

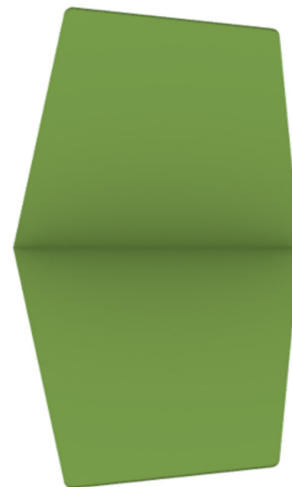
Type 4 Hush Acoustics Panel: Flutter
Not to scale

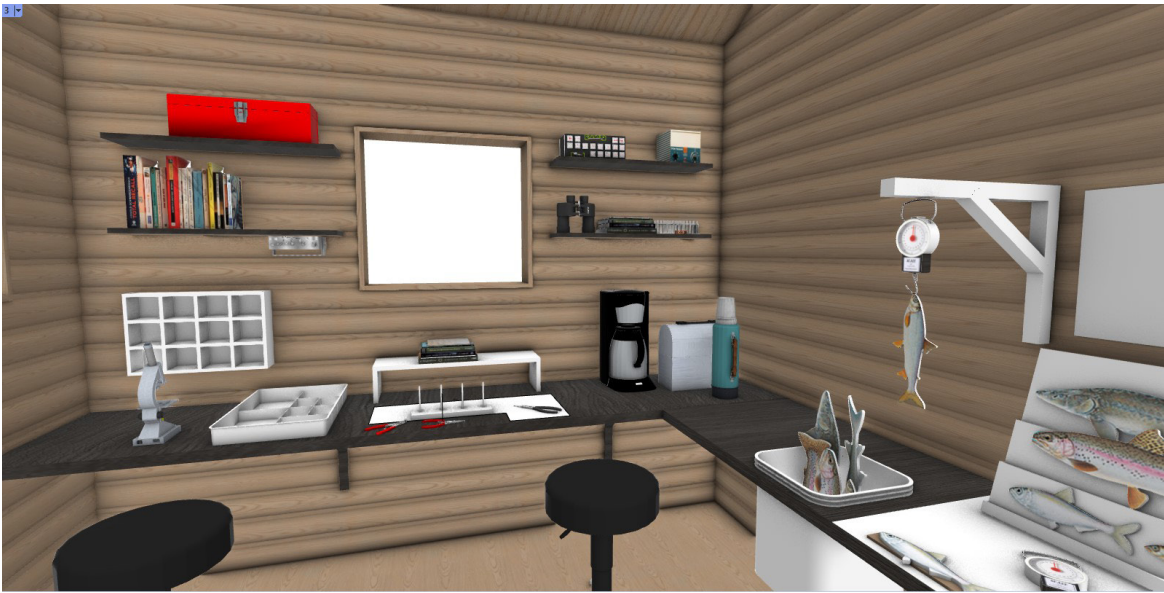
- Items as shown above
- Small custom cubie shelf, 4"x4"grid by 4" deep, solid pine painted white
 - Microscope by owner placed on table
 - Bird banding activity as per special exhibits document
 - Four 8" deep mounted shelves on steel shelf bracket mounted to cabin wall. Props provided by owner.
 - Heavy duty 18" wall mounted bracket; solid pine painted white with hand held luggage scale
 - ¼" thick pvc cut-out fish silhouettes with full face vinyl prints. Qty: 10 unique silhouettes ranging from 6" long to 20" long.
 - White bucket in hole in countertop
 - Bird banding station as per special exhibits document

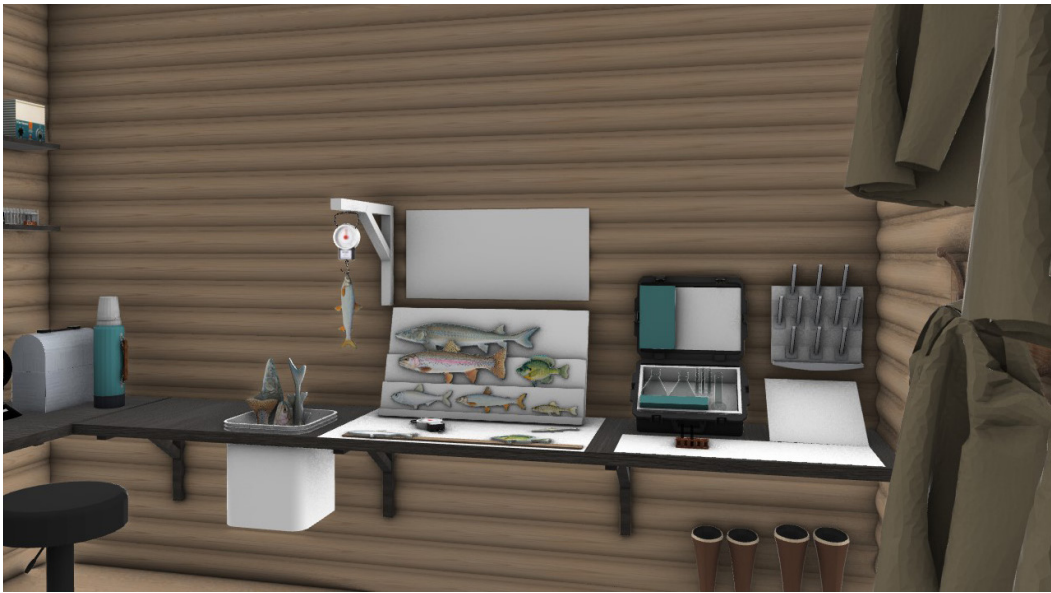
- Items as shown above
- Two (2) i-hooks in wall to hang clipboard left of fish scale bracket (no shown in illustration)
 - Purchased water testing kit with case secured mounted on angle and secured to table and back wall as shown. Custom cut ¼" thick acrylic secured to open face of case with tamper proof screws.
 - Wall mounted test tube drying rack mounted to wall
 - Custom printed ¼" place mat graphic.
 - Angled fish display with 3x ½" deep ledges, painted white

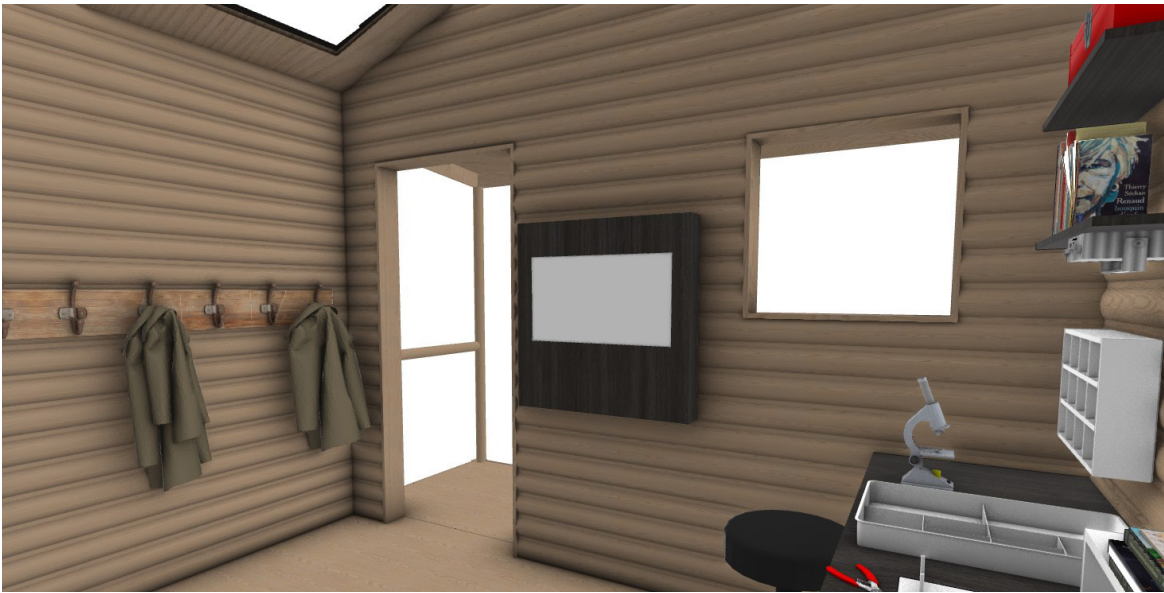
- Items as shown above
- 32" touchscreen in painted enclosure mounted to wall. (content by owner)
 - Two (2) 3' long purchased coat racks similar to illustration.

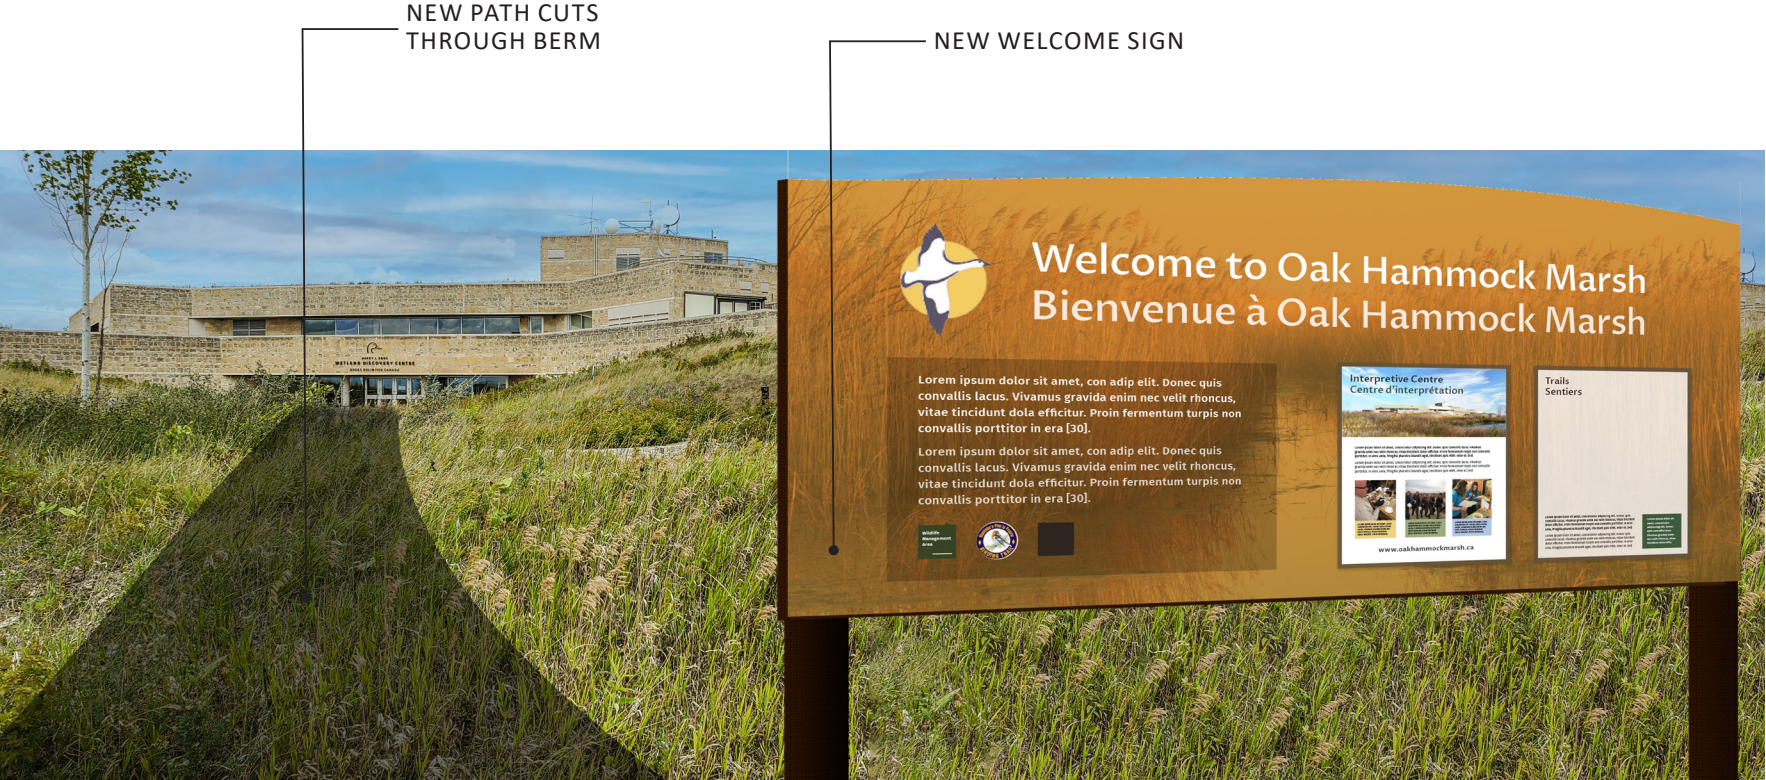
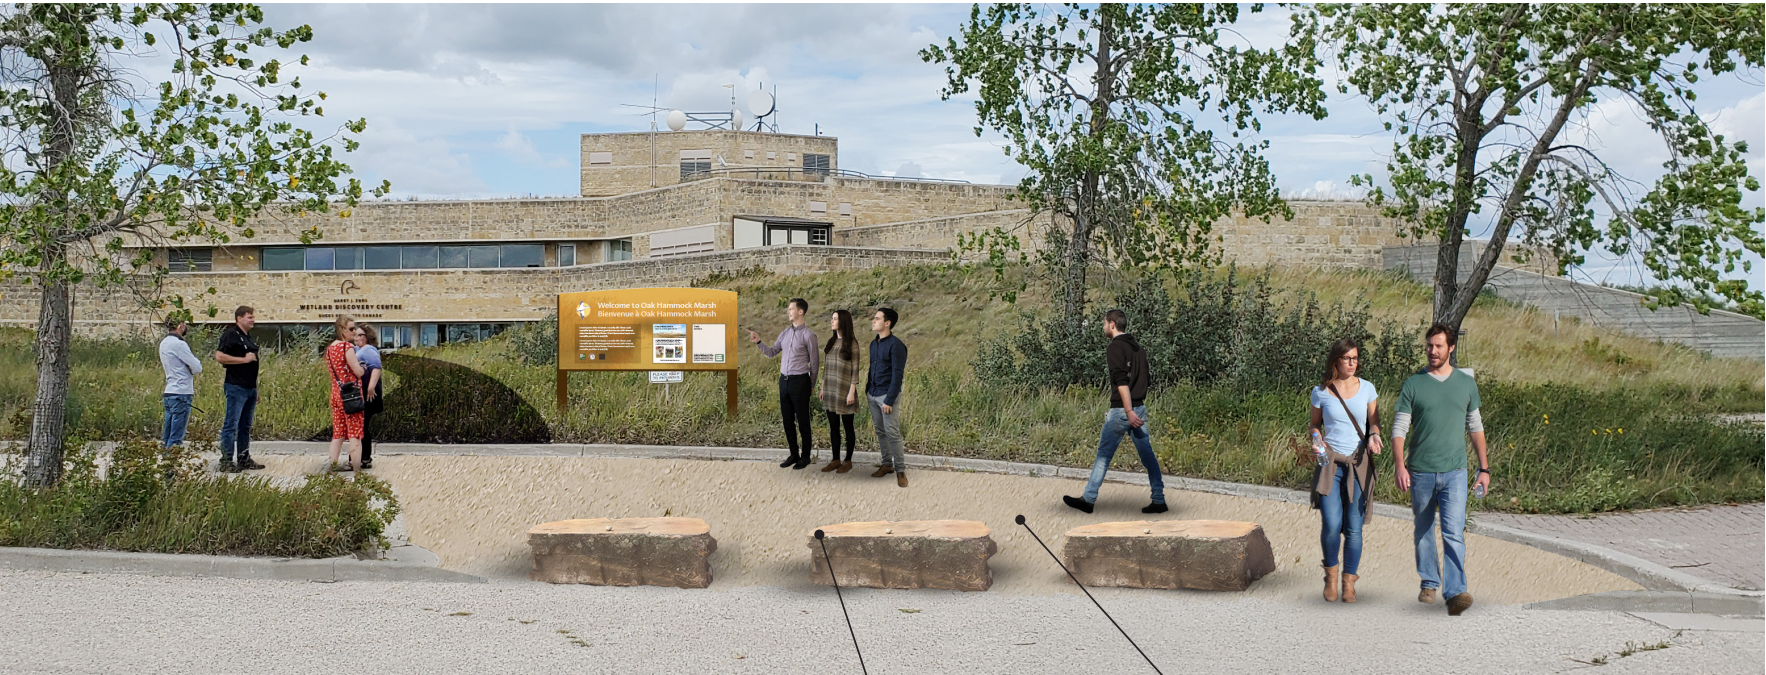
REDEVELOPED

REMOVE ASPHALT AND REPLACE WITH NEW LIMESTONE SCREENING

NEW LIMESTONE BLOCK BENCHES/ VEHICLE DETERANTS

OUTDOOR DONOR PANEL

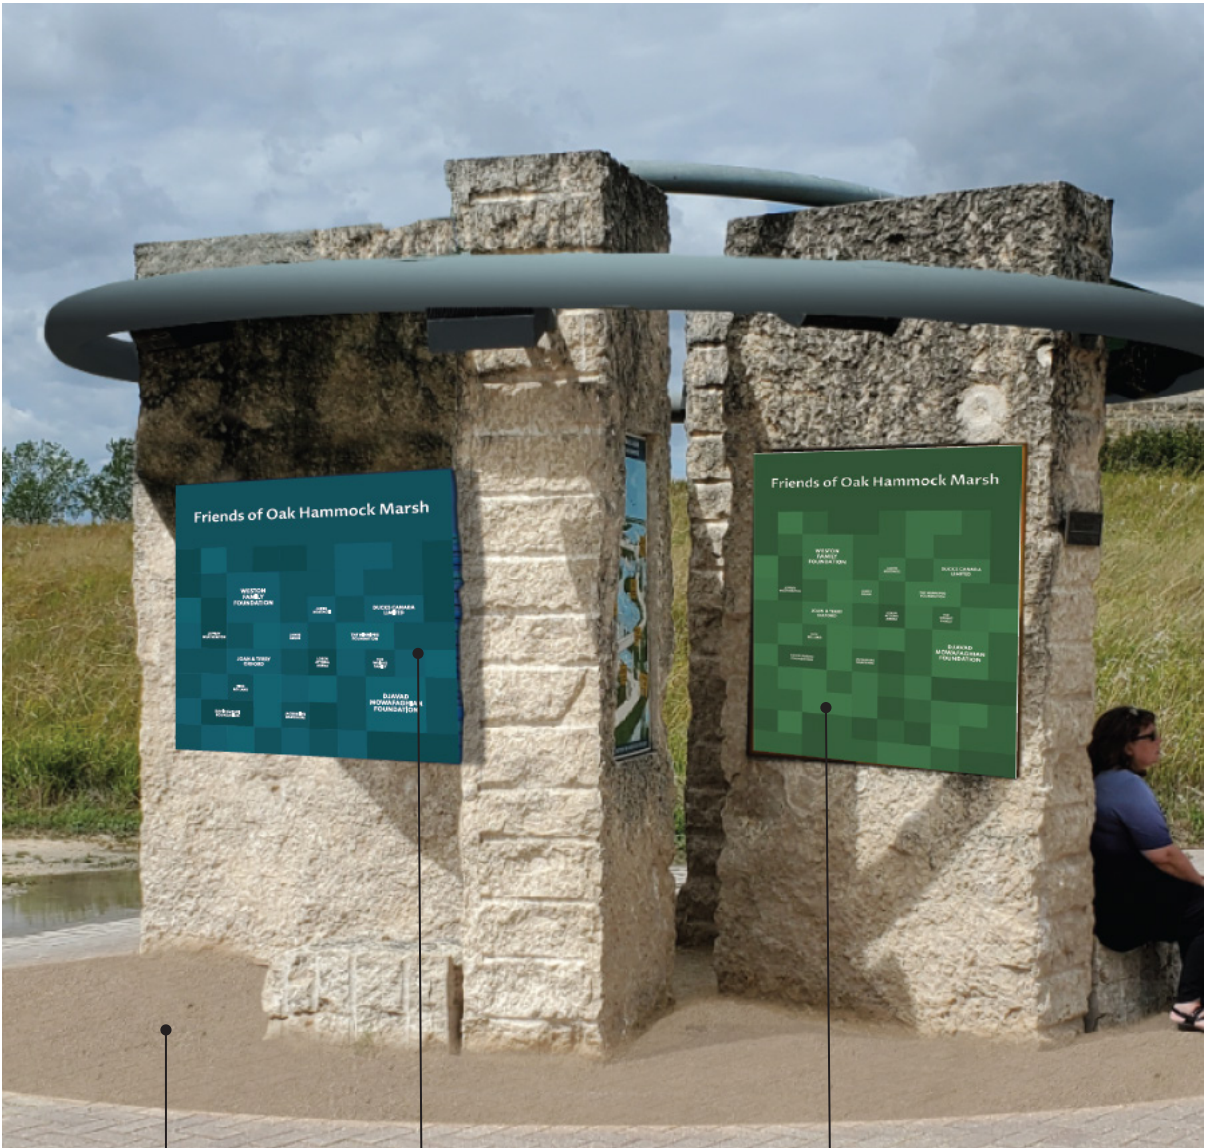
REMOVE EXISTING PAVERS AND REPLACE WITH NEW LIMESTONE SCREENING AS SHOWN

NEW DONOR PANELS OVERLAID AND MOUNTED TO EXISTING. REFERENCE GRAPHIC DESIGN SOURCE GUIDELINES

- Remove existing fabric shelter
- Repaint steel ring
- Remove existing pavers at base to create a circular ring of gravel
